**SASKATCHEWAN RIVER
LAKE STURGEON HABITAT INVESTIGATION
CUMBERLAND HOUSE, SASKATCHEWAN
TO
THE PAS, MANITOBA
JUNE, 2000**

*SASKATCHEWAN RIVER
LAKE STURGEON HABITAT INVESTIGATION
JUNE, 2000*

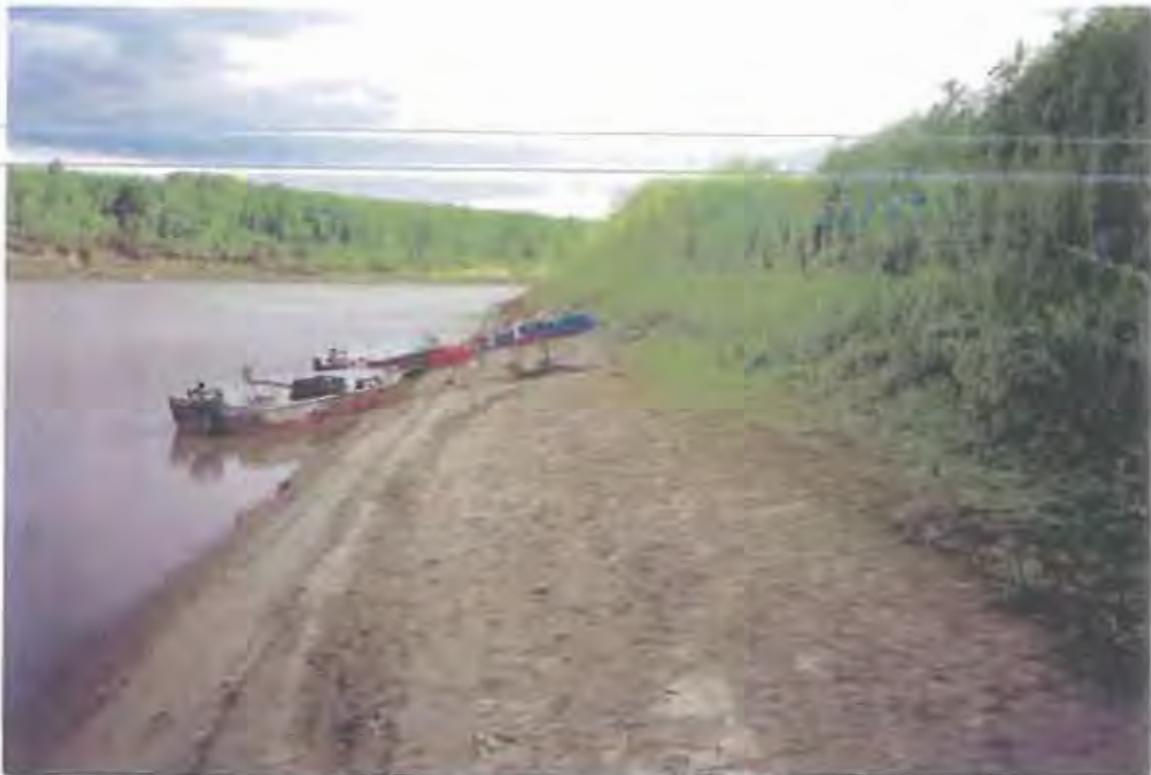
Figure 48. Camp location illustrating typical shorelines. Note deposition on near shore (inside bend) and eroding shoreline on far shore (outside bend).

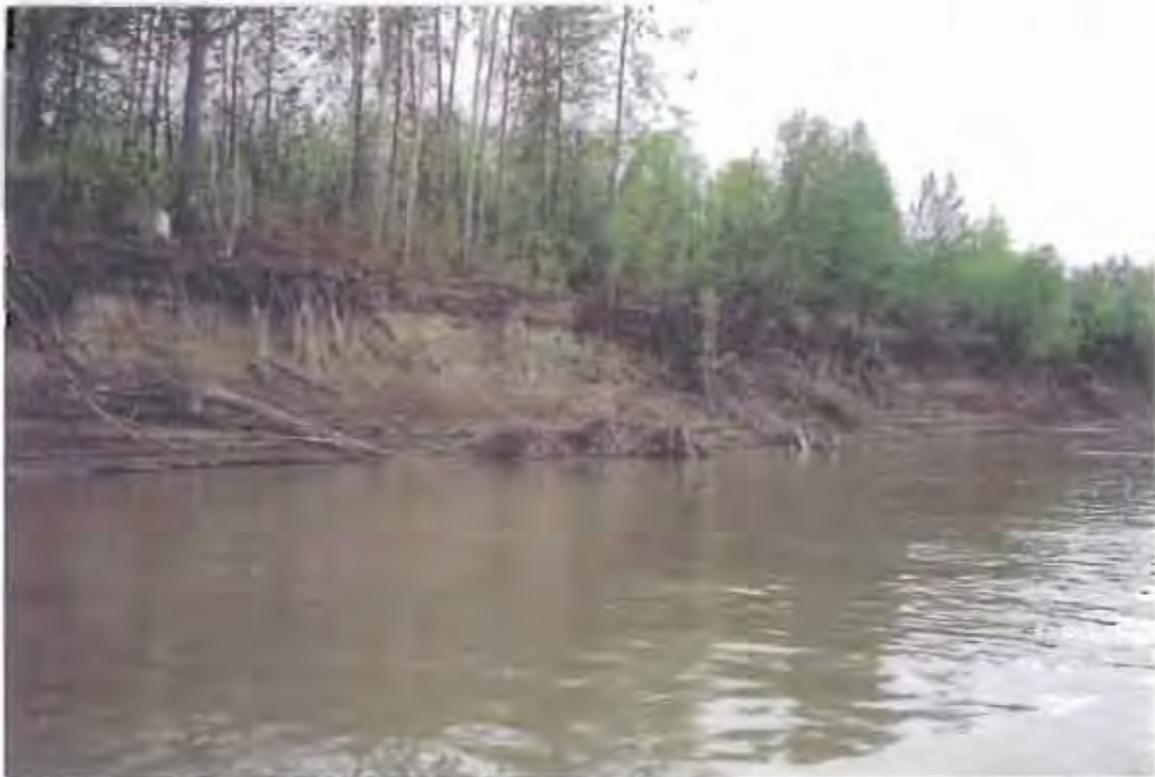
Figure 49. Bank instability (slumping) on outside river bend, a common shoreline feature throughout the study area.

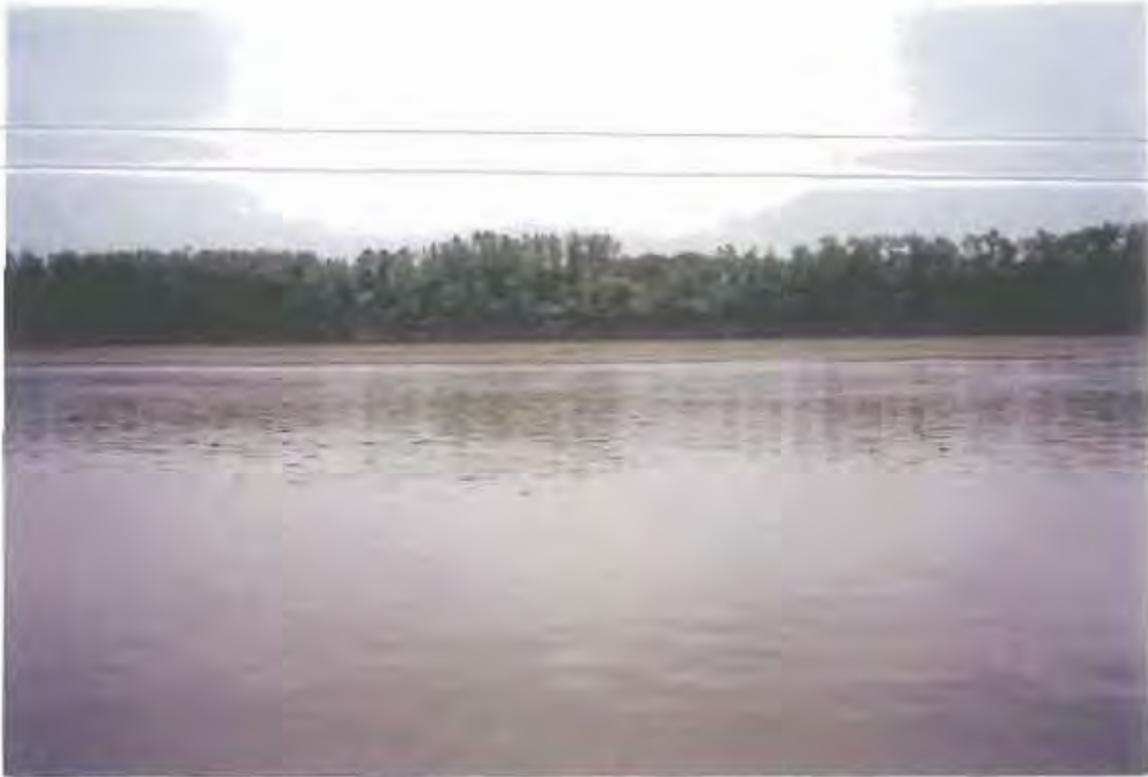
Figure 50. Area exhibiting exposed, flat expanses of sand and pea-sized gravel in upper reach of study region in Saskatchewan.

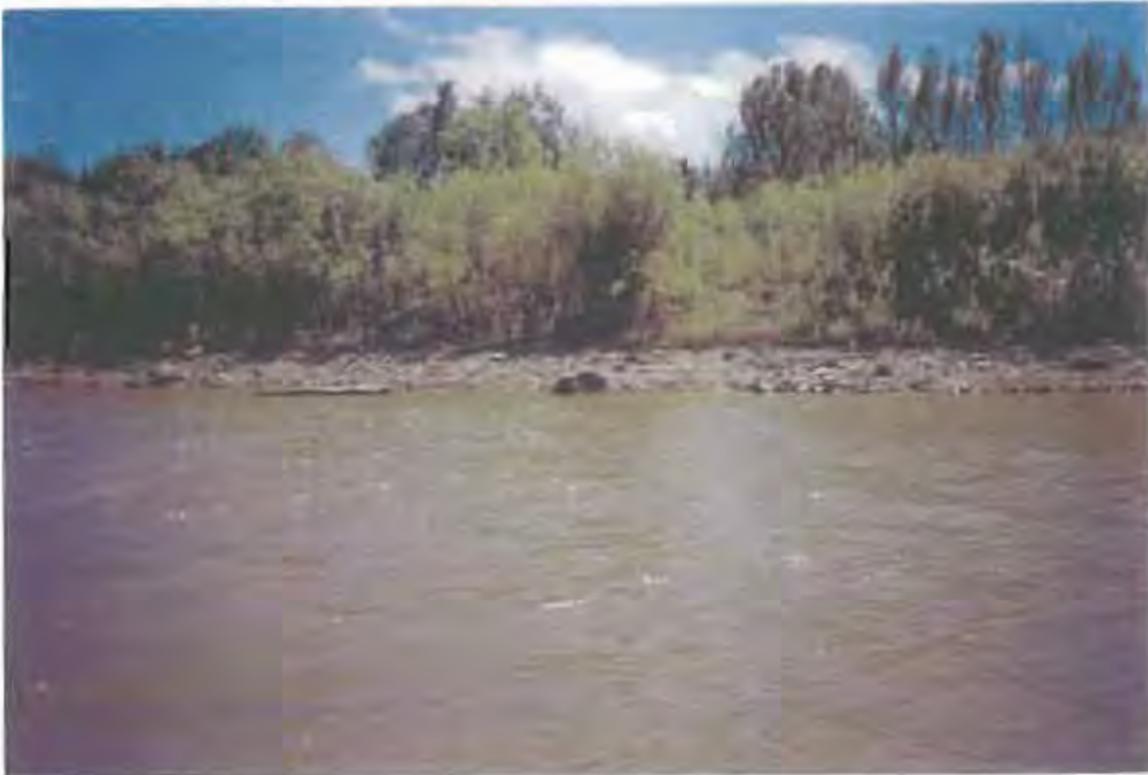
Figure 51. Shoreline composed of boulder and cobble in the lower reach of the study area, near The Pas, Manitoba.

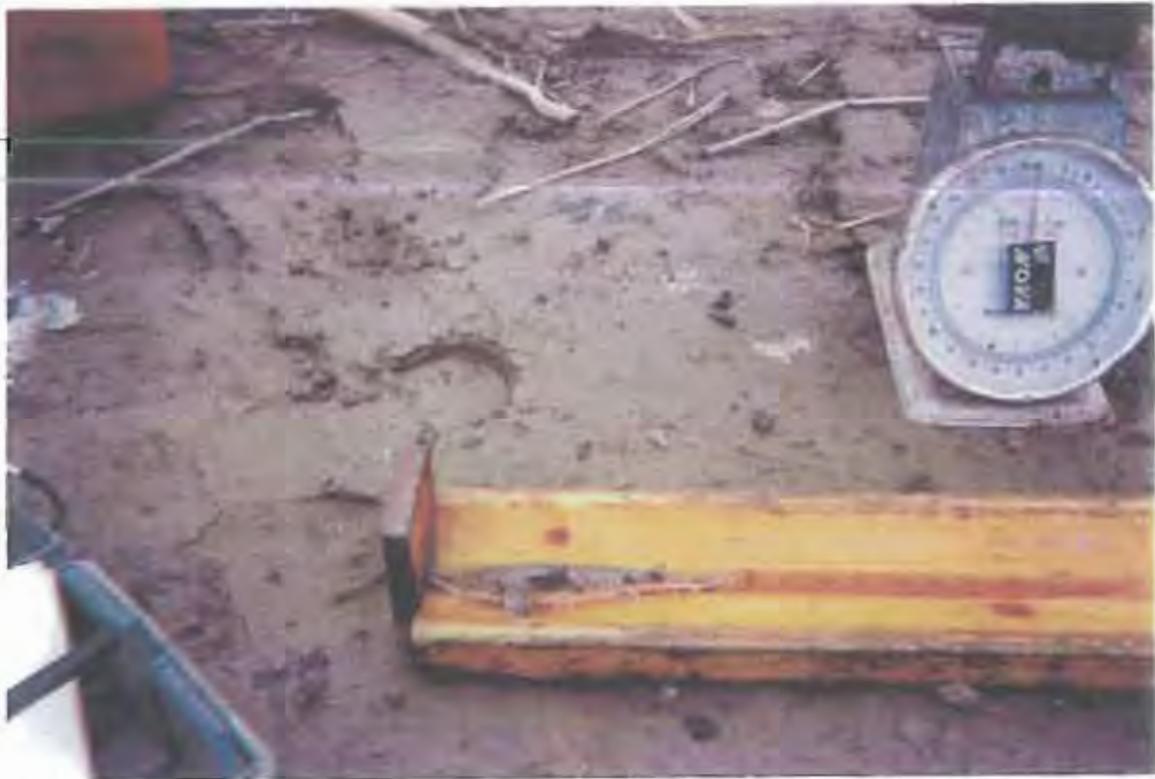
Figure 52. Juvenile lake sturgeon captured at GN-29 Site downstream of "Big Bend" in Manitoba.

A single 123 mm juvenile sturgeon (Figure 52) was captured in 3" (76 mm) mesh at GN-29 Site downstream of "Big Bend" (Figure 21). The site had a mean depth of 6.15 m and a mean water velocity of 0.50 m/s. Substrate was primarily sand, with a small amount of silt and gravel. The juvenile lake sturgeon weighed approximately 50 g and was determined to be two years of age (Table 4).

The reach encompassing transects 11 to 95, including the Tearing River mouths (1st and 2nd outlets), the Manitoba/Saskatchewan border, and Big Bend, provides uniform, deepwater run habitat with substrates composed primarily of sand. Within this reach, near Transect 93, a single 123 mm, two year-old sturgeon was captured (Figure 52). Kempinger (1996) reported that all young-of-the-year (YOY) sturgeon captured during a study in the Wolf River, Wisconsin, were taken on flat substrates composed of coarse sand and pea-sized gravel, where there was a detectable current. Substrates with rooted aquatic plants did not yield any young lake sturgeon. Sibkin and Bibikov (1988 in Kempinger 1996) stated that "young [sturgeon] apparently avoid zones with vegetation because such zones are mechanical factors that hinder their feeding, orientation, and movement". Observations of captive lake sturgeon in aquaria also have shown that young sturgeon clearly prefer a sandy substrate and avoid uneven bottoms and vegetation (Sibkin and Bibikov 1988, in Kempinger 1996; Steve Peake, North/South Consultants Inc. pers. comm.; S. Matkowski, Manitoba Fisheries Branch, Fish Culture, pers. comm.). Kempinger (1996) suggested that the preference of young sturgeon for sand substrates

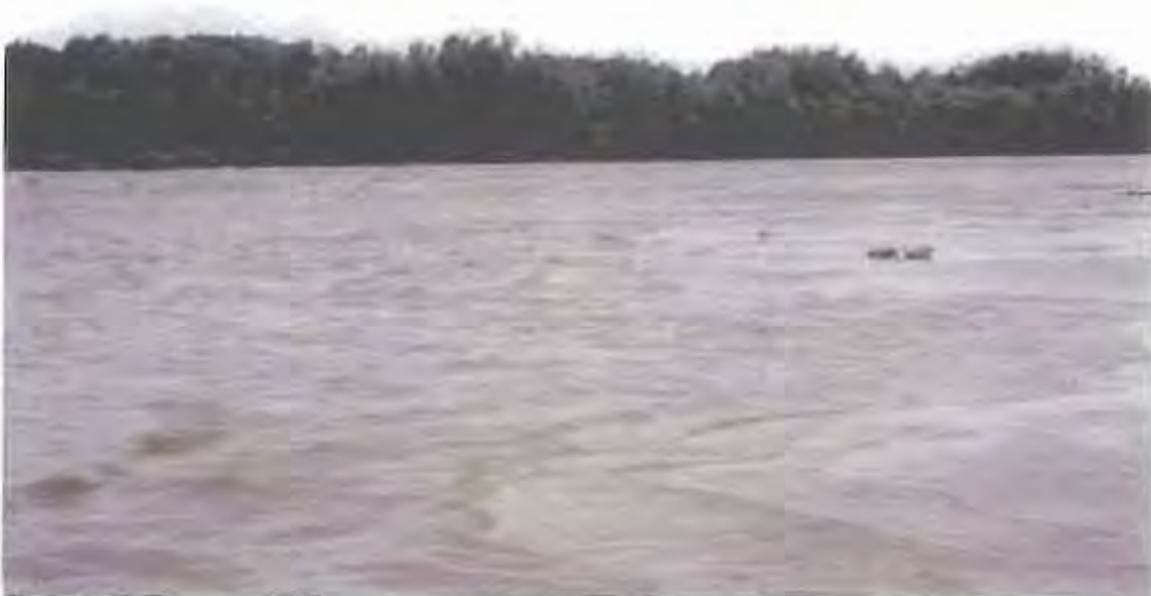
Figure 53. Bigstone Rapids at Cumberland House, Saskatchewan, June, 2000. Note bedrock shelf (right bank facing upstream) located immediately downstream of rapids.

Bigstone Rapids was the only location within the study area that was determined to provide suitable spawning habitat for lake sturgeon during the investigation period. However, as a result of low spring flows and a relatively slow increase in water temperatures, it was suspected that majority of lake sturgeon may have been dissuaded from spawning during spring, 2000. In the 10 km downstream of Bigstone Rapids, substrates were suitable for sturgeon spawning (e.g. a high proportion of boulder, cobble, and gravel substrate), but depths were generally greater than 2 m. An absence of turbulent water (which by most accounts, seems to be a pre-requisite for successful lake sturgeon spawning), suggests that there are no other suitable spawning locations downstream of Bigstone Rapids.
